**TECHNICAL SERVICE BULLETIN
RAFNA RAILGEAR**

TSB NUMBER: TSB185

All R290 Railgear

SUMMARY:

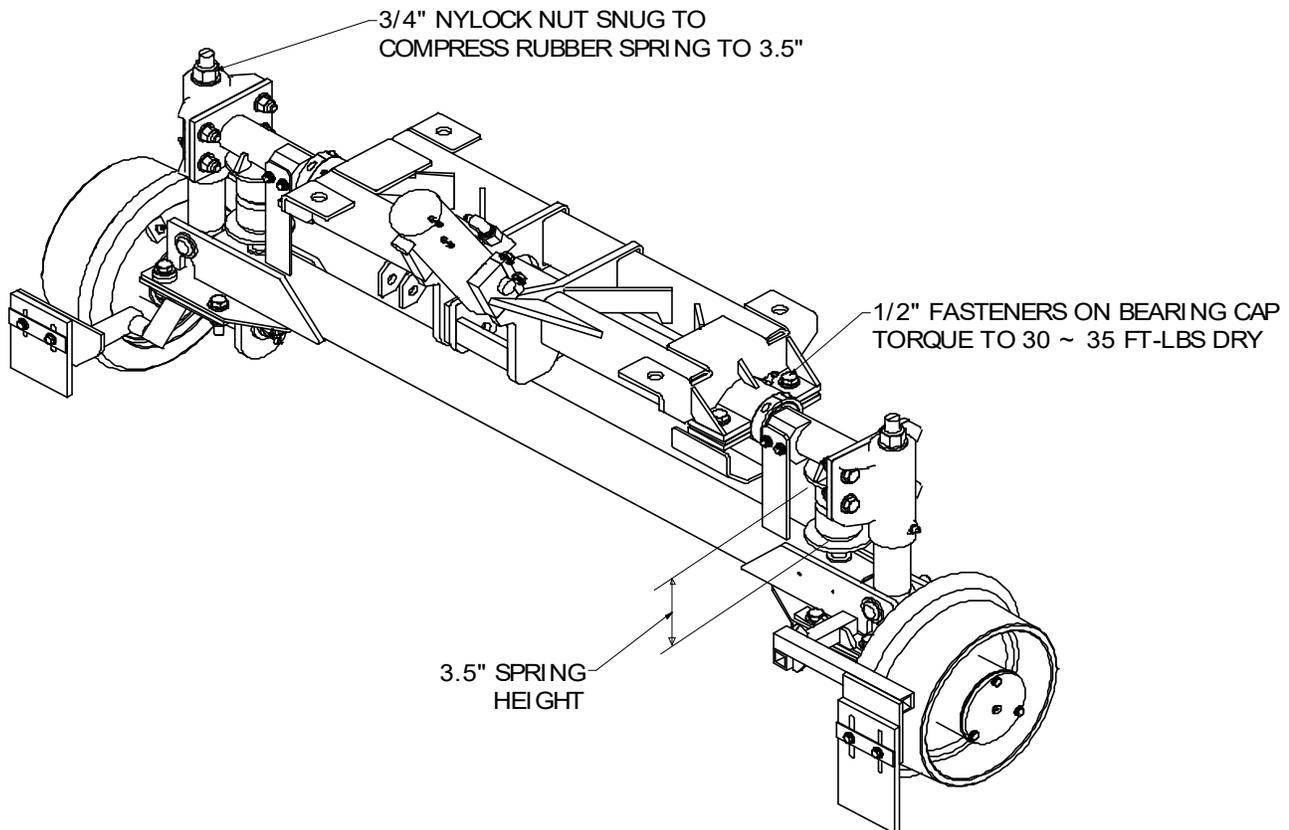
NON-STANDARD FASTENER TORQUE VALUES

Problems with bearing caps being over torqued which caused the lower assembly from rotating with the upper assembly.

Can cause additional stress on pump motor, which in turn can cause overheating of the pump motor.

The attached drawings calls out the correct torque setting to be applied to the 1/2" fasteners used on the bearing caps. This setting must be 30 ~ 35 FT-LBS dry. If this setting is applied and rotation issues still occur please contact G & B field service, or G & B engineering for assistance.
