TECHNICAL SERVICE BULLETIN			
ISSUE DATE:	07/10/18	TSB NUMBER:	TSB-198
HAZARD / URGENCY RATING			
X	DANGER - Physical harm is possible if TSB is not observed or followed		
X	WARNING - Equipment damage is possible if TSB is not observed or followed		
X	CAUTION - Essential issue affecting operation, service, parts or installation		
	INFORMATIONAL - Advisory which may be of interest

ALL RAFNA R-460 REAR RAILGEAR BEING INSTALLED ON A 2017/2018 FORD F450/F550 GAS OR DIESEL WITH A METAL FUEL TANK CRADLE.

FORD MID PRODUCTION HAS MADE A CHANGE TO THE VEHICLE'S FUEL TANK CRADLE CAUSING INTERFERENCE WHEN INSTALLING THE R-460 REAR RAILGEAR ON THE VEHICLE.

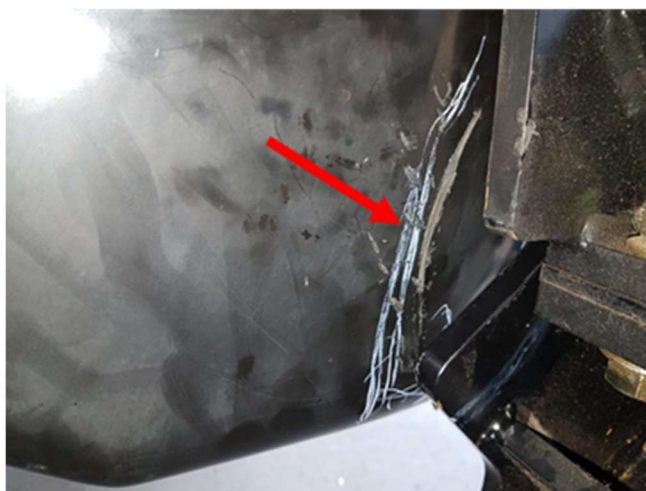
1. THE DRIVER'S SIDE PIVOT BOX COMES IN CONTACT WITH THE TANK CRADLE.

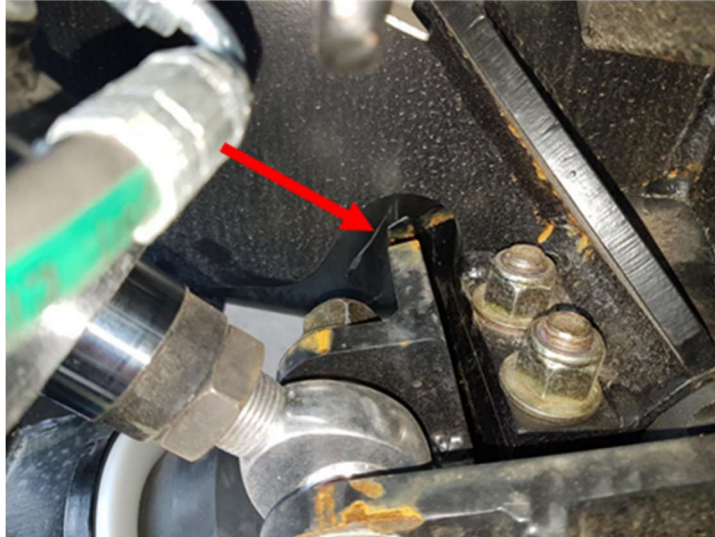
2. THE PASSENGER'S SIDE PIVOT BOX ALSO COMES IN CONTACT WITH THE TANK CRADLE.
G&B Specialties Inc. 535 West 3rd Street, Berwick, PA, USA Tel: 1-570-752-5901 Fax: (570) 752-6397

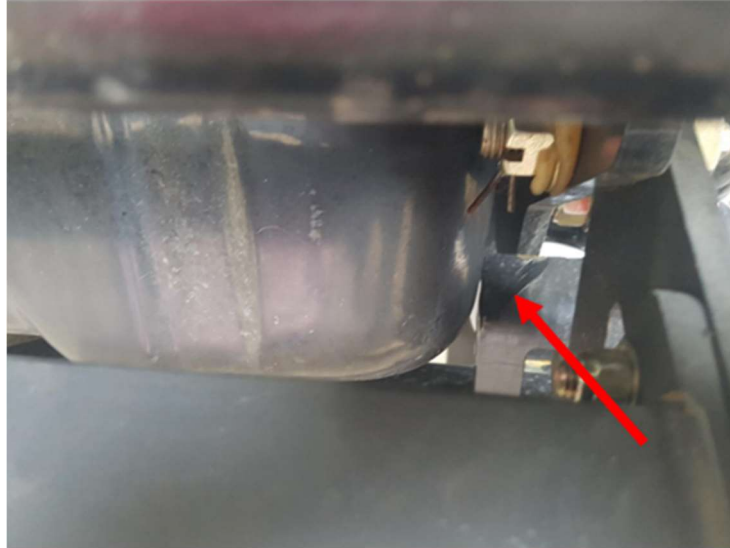
3. THE AXLE LOCK LATCH IS ALSO AN AREA TO BE ADDRESSED.

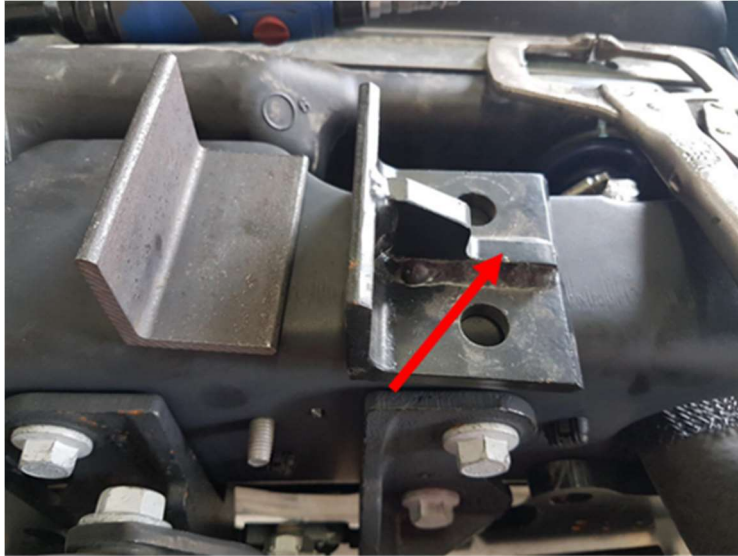
4. FINALLY, THE ANGLE BRACKET NEEDS TO BE MODIFIED TO AVOID INTERFERENCE.
