**TECHNICAL REFERENCE BULLETIN
RAFNA RAILGEAR**

TRB NUMBER: TRB-
05262016

All RAFNA railgear utilizing the S-002002 single po check valve.

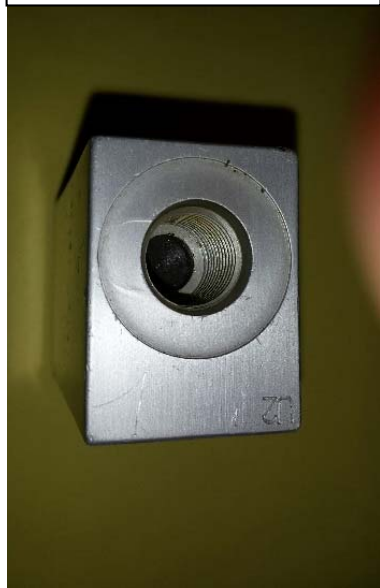
VALVE PISTON INSTALLED

Inspect port U-2 visually for the valve piston on any S-002002 single po check valve shipped loose. Any gear shipped with the S-002002 valve installed will have to be removed to inspect for the valve piston.

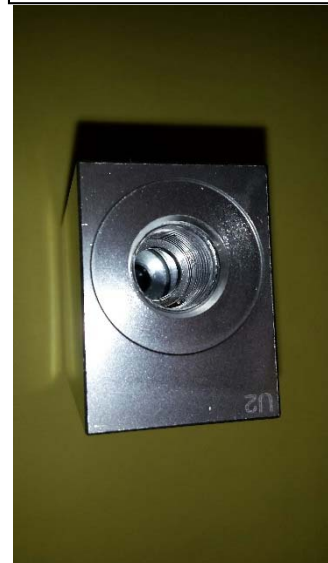
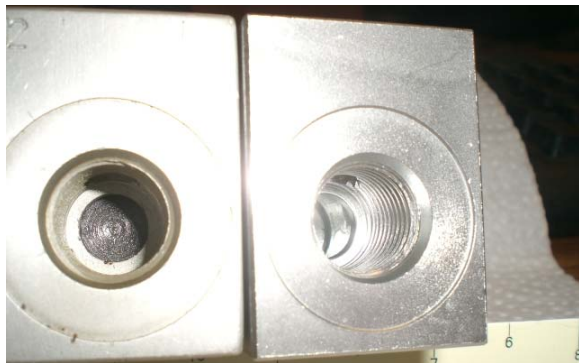
It has come to our attention that some of these check valve are missing the valve piston that operates the check valve.

If a bad check valve is installed in the hydraulic system it will not let the cylinder operate properly, do to fluid bypassing from one port to the other causing the hydraulic system to deadhead.

VALVE PISTON MISSING

Contact RAFNA for replacements if needed.
