RAFNA TECHNICAL SERVICE BULLETIN No. 158
Rafna R-450 and R-450OT Mounting Box Interference on
2004 Ford F-450/550 Vehicles

Issued March 11, 2004

This Technical Service Bulletin is applicable to 2004 Ford F-450/550 vehicles equipped with Rafna's model R-450 or R-450OT railgear.

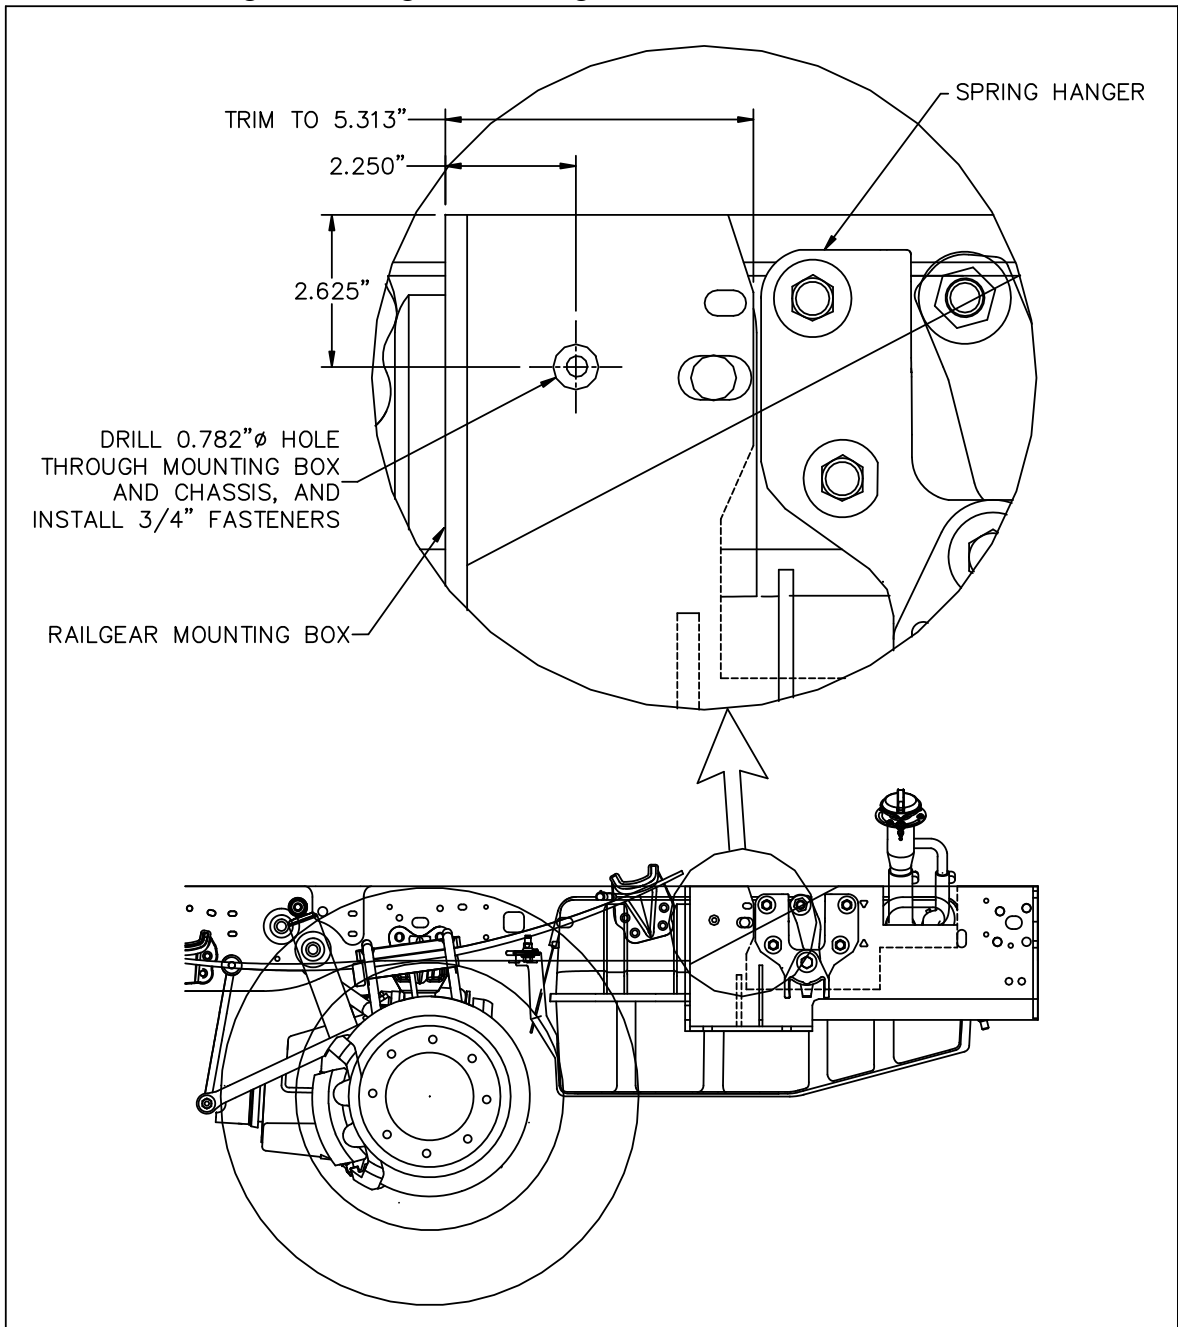
Figure 1. Railgear Mounting Box Modifications

During installation, it may be found that there is interference between the Rafna railgear mounting box (R-4804D/P or R-4872D/P) and the vehicle's rear spring hanger. This interference is caused by a change in the shape of the spring hanger on some vehicles. The affected vehicles are equipped with a stamped spring hanger; vehicles equipped with a cast spring hanger should not experience any interference.

For vehicles on which the spring hangers are interfering with the railgear mounting boxes, the railgear mounting boxes must be modified as follows (see attached figure for dimensions):

1. Trim the rear edge of the front section of the railgear mounting box as shown;
2. Install the railgear mounting box as outlined in the installation manual;
3. Drill an extra hole through each railgear mounting box and chassis;
4. Fasten an extra $\frac{3}{4}$ " bolt along with two washers and a nylock nut in each of the two newly-drilled holes; and
5. Torque the $\frac{3}{4}$ " fasteners to 175 ft-lbs.

1. Two $\frac{3}{4}$ " UNC Gr.8 bolts x 3" long;
2. Four $\frac{3}{4}$ " Gr. 8 washers; and
3. Two $\frac{3}{4}$ " UNC Gr. 8 nylock nuts.
