TECHNICAL SERVICE BULLETIN RAFNA RAILGEAR

RAFNA R-080 DISC-LOCK NUT AND R-071 WHEEL STUD TORQUE

ISSUE DATE: June 23, 2004 **TSB NUMBER:** TSB-161 Rev 0

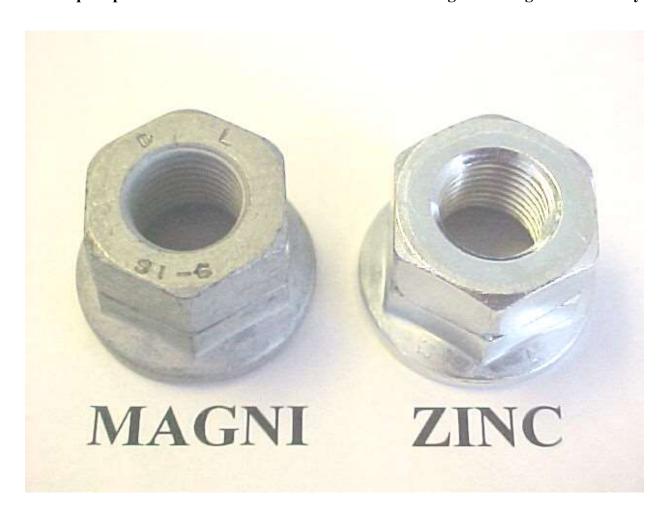
The zinc coated disc-lock nut and the Magni coated disc-lock nut can be identified as follows (see attached photograph):

Zinc Coated R-080 Disc-Lock Nut: Shiny silver appearance, no markings other than possible stamping of the digits "D" and "L" in the disc portion of the nut.

Magni Coated R-080 Disc-Lock Nut: Dull gray appearance, stamping of digits "D", "L" and "9-16" in the face of the hex portion of the nut.

Torque Specification For R-080 Disc-Lock Nuts w/ Zinc Coating: 165 ft-lbs dry.

Torque Specification For R-080 Disc-Lock Nuts w/ Magni Coating: 125 ft-lbs dry.
