**TECHNICAL SERVICE BULLETIN  
RAFNA RAILGEAR**

**TSB NUMBER:** TSB184

**SUMMARY:**

The hydraulic installation/operations manual for certain R-290 railgear applications may incorrectly show the location of the emergency override decals. The locations of the the decals shown in some manuals may not correspond with the hydraulic schematic shown in the same manual. The hydraulic schematics shown in the installation/operations manual is correct.

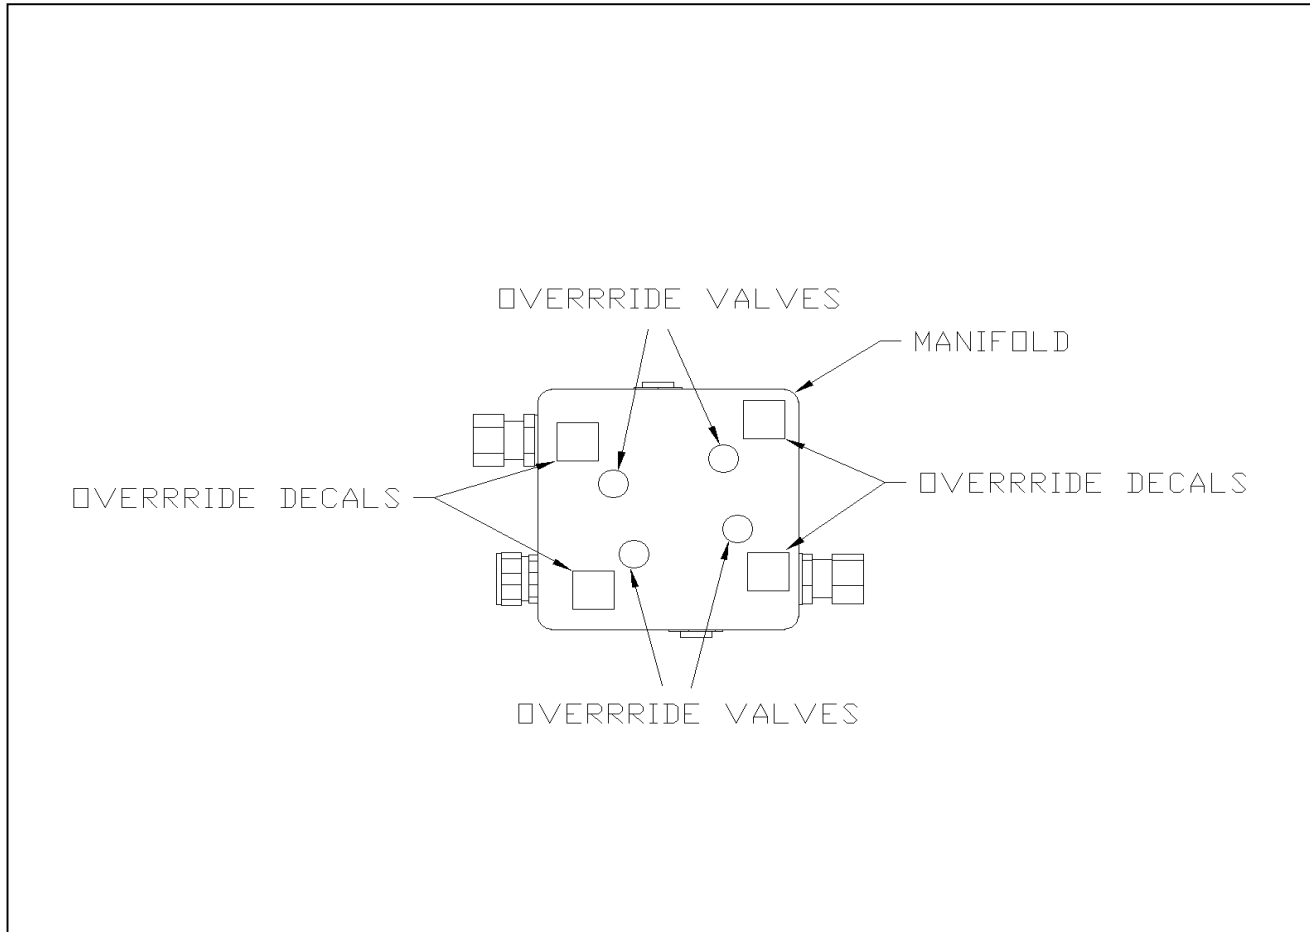
**OVERRIDE DECALS MAY OR MAY NOT BE IN CORRECT LOCATION**

Test and label each override one at a time to insure proper labeling and operation. The test procedure for the emergency overrides can be found in the railgear hydraulic manual for the installed vehicle.(to operated the manifold overrides push down and turn counterclockwise to open / push down and turn clockwise to close)
