TECHNICAL SERVICE BULLETIN	
ISSUE DATE: 05/06/19	TSB NUMBER: TSB-200
HAZARD / URGENCY RATING	
X	DANGER - Physical harm is possible if TSB is not observed or followed
X	WARNING - Equipment damage is possible if TSB is not observed or followed
X	CAUTION - Essential issue affecting operation, service, parts or installation
X	INFORMATIONAL - Advisory which may be of interest

ALL RAFNA R-290 RAILGEAR, R-450 RAILGEAR, AND R-460 RAILGEAR EQUIPPED WITH THE R-020 RAIL WHEEL SHIPPED BETWEEN FEBRUARY 1, 2019 TO MAY 1, 2019.

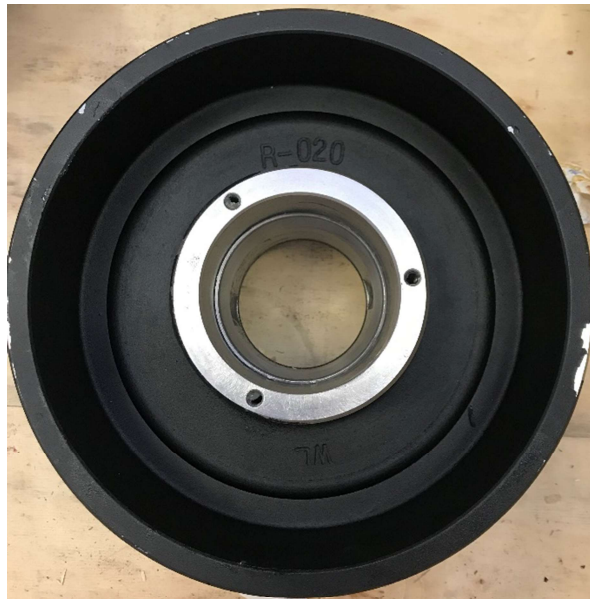
THE R-290/R-450/R-460 RAIL WHEELS MAY HAVE AN INSUFFICIENT AMOUNT OF GREASE TO COMPLETELY ENCASE REAR CAVITY FROM FACTORY.

PREMATURE WEAR OF WHEEL BEARINGS, AND IF LEFT UNADDRESSED, FAILURE OF THE WHEEL BEARINGS.

ENSURE WHEELS ARE PROPERLY FILLED WITH GREASE BEFORE ATTEMPTING HIRAIL.

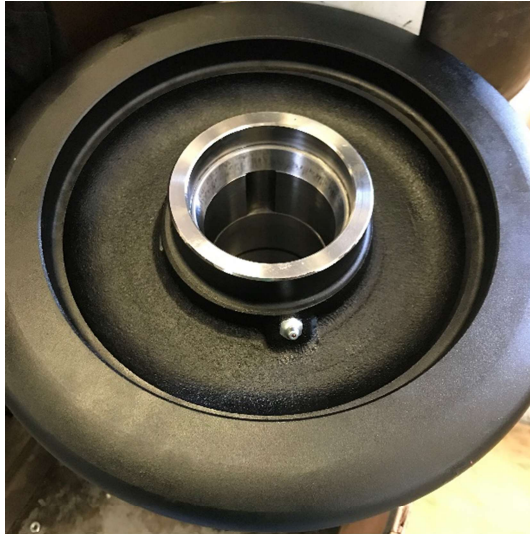
1. INSPECT RAIL WHEEL BY ROTATING THE WHEEL AND LISTENING/FEELING FOR ANY IRREGULARITIES.
2. APPLY GREASE TO THE RAIL WHEEL THROUGH GREASE FITTING LOCATED ON THE BACKSIDE (FLANGE SIDE) OF THE WHEEL.

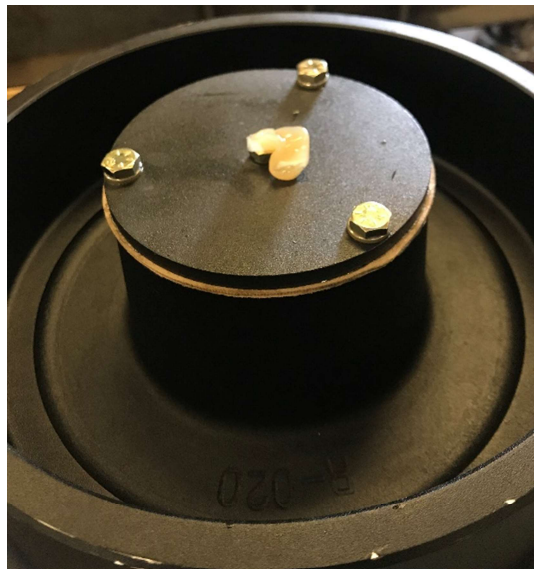
3. WHEN ADEQUATELY GREASED, GREASE SHOULD START TO FLOW OUT OF THE RELIEF LOCATED IN THE CENTER OF THE HUB CAP AND GREASING CAN NOW CEASE.

4. CLEAN/REMOVE THE EXCESS GREASE FROM THE RELIEF.
5. WHEEL IS NOW READY FOR USE
